Bacton Review

# Fire & Gas Mapping Optimisation Project

Charlie Bradshaw  
Internship  
Odgen Trust

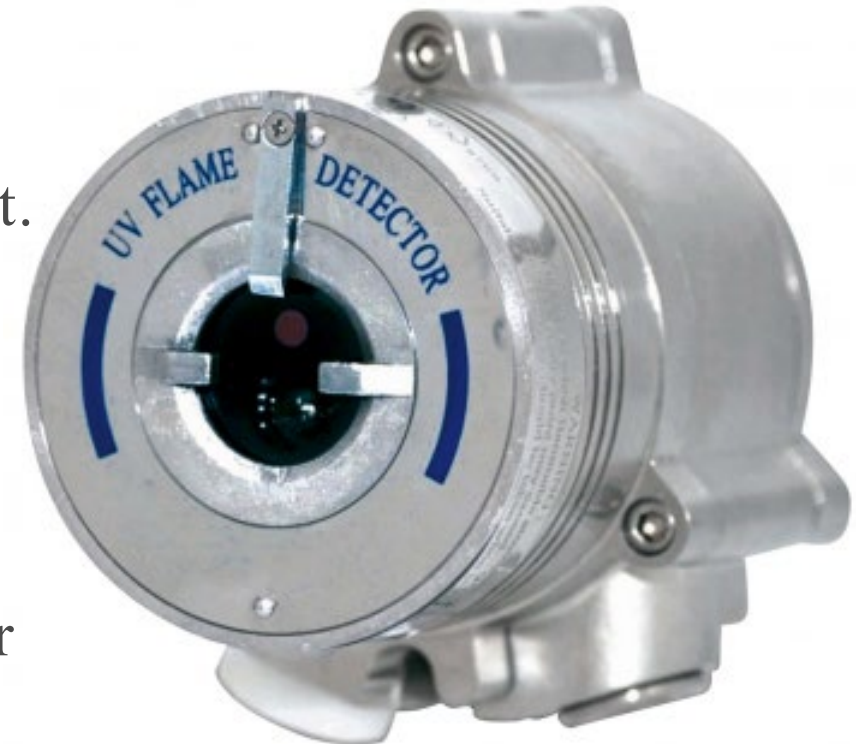
## UV Flame Detector

- This device works through a flame emitting ultra violet (UV) light. The UV flame detector will contain a UV sensor that is sensitive to UV radiation. This radiation will be emitted by a fire allowing the device to detect it. This enables a fast and quick response sent back to the control room.
- In most situations the UV sensor will filter out any other light sources (natural or artificial light), but potential other light sources may trigger a false alarm.

| | Response Speed | False Alarm Immunity | Outdoor Suitability | Detection Range | Maintenance Requirements | Relative Cost | Total |
|---|---|---|---|---|---|---|---|
| UV Flame Detector | Very Fast | Low to Moderate | Fair | Short to Medium | Low | Low | 14 |

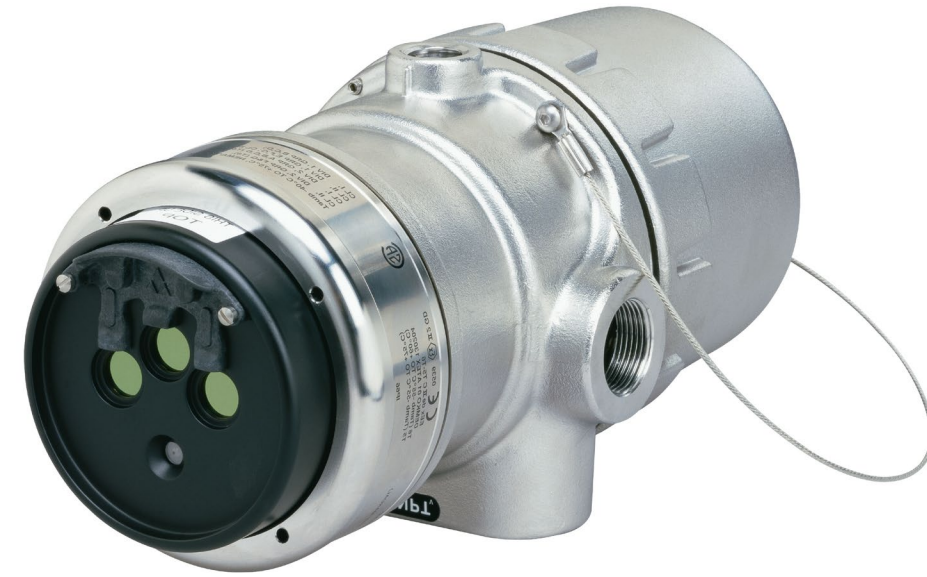
## Single Frequency IR Flame Detector

- Commonly used for facilities that process hydrocarbon gas or liquids, fires or other fuels, such as hydrogen or methanol. (Which may be impossible for the sensor to see or very poorly detected).
- The device works through the pyro-electric detector responding to changes in IR radiation and will be sensitive between 2 to 20 meters.

| | Response Speed | False Alarm Immunity | Outdoor Suitability | Detection Range | Maintenance Requirements | Relative Cost | Total |
|---|---|---|---|---|---|---|---|
| Single Frequency IR Flame Detector | Fast | Moderate | Good | Medium | Low | Low to Medium | 15 |

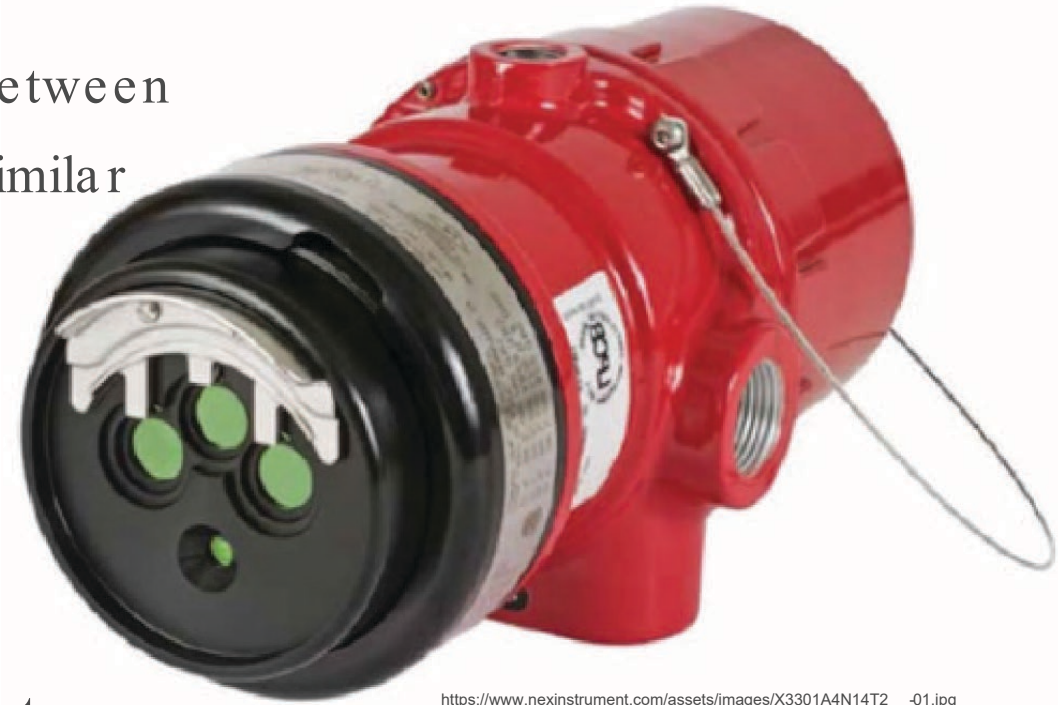
## Multi Frequency IR Flame Detector

- These devices will use multiple IR sensors to help reduce false alarm activations. This is through a large number of variants available for different sensitivities of fuels types (such as hydrogen).
- To determine a fire, the device will look for relationships between signals of each sensors. If mostly all the relationships are similar and are signalling, there is a possible fire. A signal will be sent to the control room allowing for procedures to be carried out.
- However, water can unbalance the relationships causing false alarms or making the devices unable to detect incidents.

| | Response Speed | False Alarm Immunity | Outdoor Suitability | Detection Range | Maintenance Requirements | Relative Cost | Total |
|---|---|---|---|---|---|---|---|
| Multi Frequency IR Flame Detector | Fast | Very High | Excellent | Long | Low to Moderate | High | 17 |

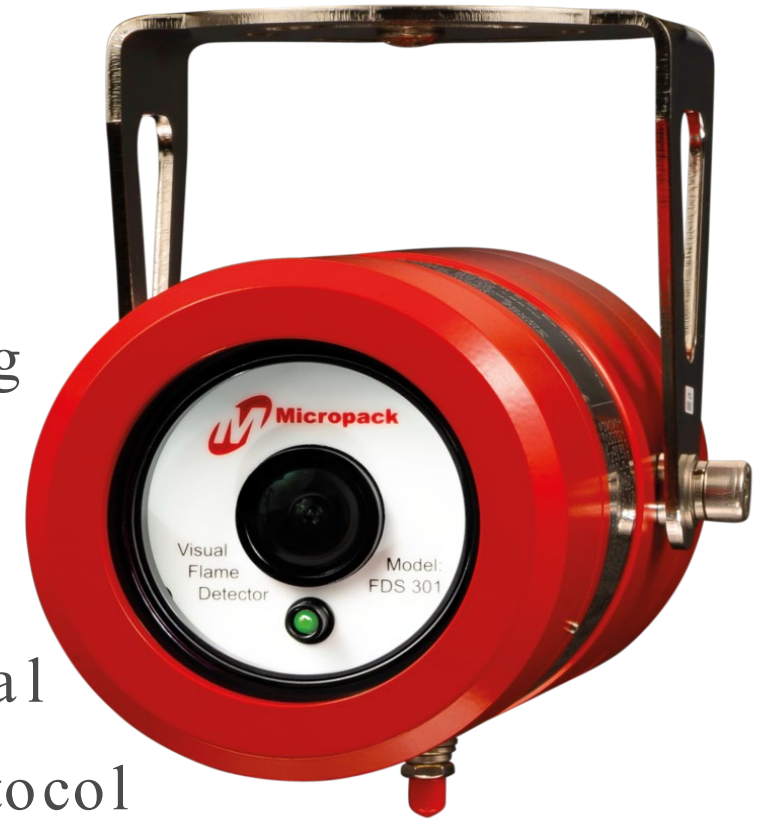
## Visual Imaging Flame Detector

- This device will process live video images to detect for hydrocarbon flames. It will utilise digital signal processing and flame detection algorithms.
- Once they detect the hydrocarbons it will transmit a signal back to control room allowing them to carry on with protocol to prevent the fire from becoming more dangerous.
- However visual flame doesn't respond to or detect flare reflections. (Flare reflections is an image that occurs when light scatters of flares within a lens system.)

| | Response Speed | False Alarm Immunity | Outdoor Suitability | Detection Range | Maintenance Requirements | Relative Cost | Total |
|---|---|---|---|---|---|---|---|
| Visual Flame Detector | Moderate to Fast | High | Good | Long | Moderate to High | High | 13 |

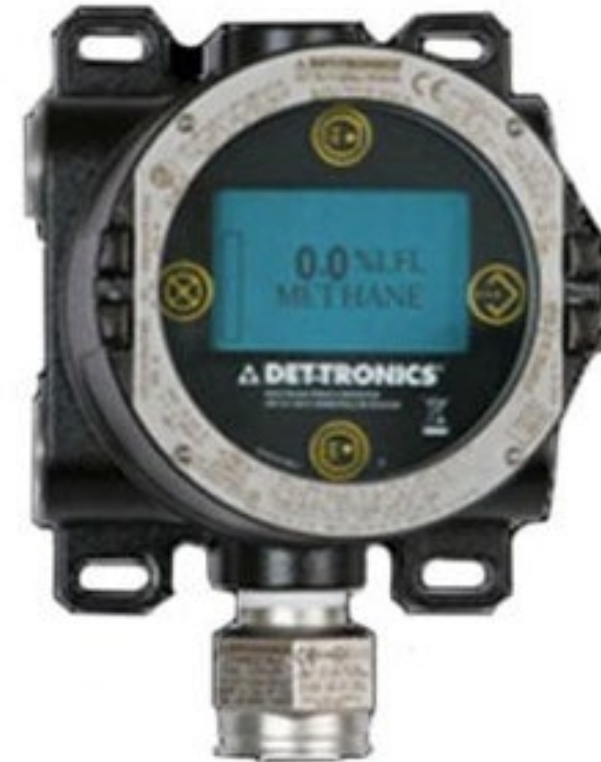
## Catalytic Bead Gas Detector

- Mainly used in older installations and is no longer approved by the HSE.
- This device will burn gas and measure the temperature rise in a sensor. Beads are electrically heated platinum wire coil. Gas diffuses through a sintered disk and a combustible mixture passes over the hot catalyst surface. Combustion then occurs, heat involved increases the temperature of the bead. Resistance is measured using the coil as the temperature thermometer standard bridge circuit.
- They are used to detect non-hydrocarbon gasses, for example hydrogen. However, the sensor may drift resulting in required regular calibration. The catalyst also may become poisoned as well, leading to failed response to gas.

| | Response Speed | False Alarm Immunity | Outdoor Suitability | Detection Range | Maintenance Requirements | Relative Cost | Total |
|---|---|---|---|---|---|---|---|
| Catalytic Bead Detector | Good | Moderate | Good | Localised | High | Low | 14 |

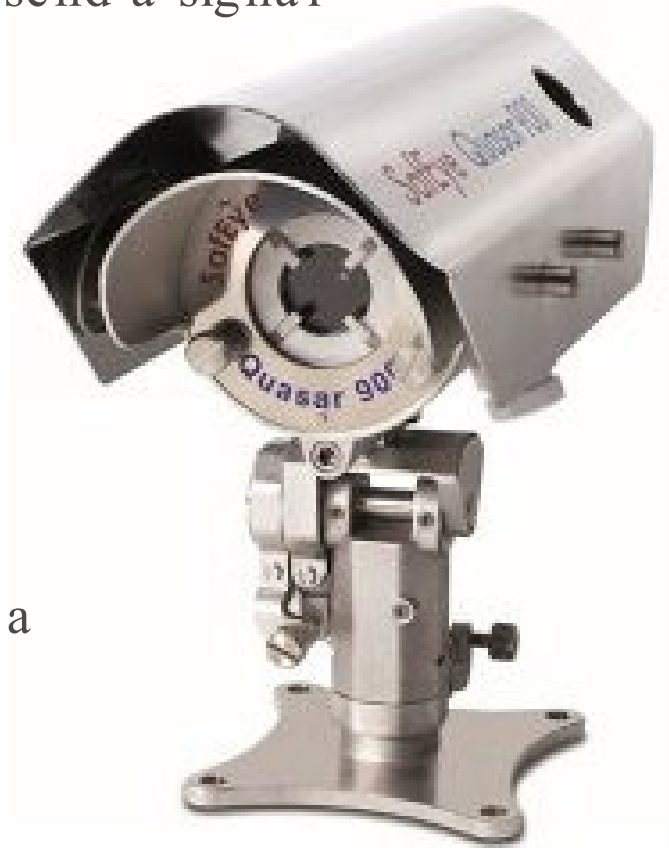
## Laser Open Path Gas Detector

- This device uses the addition of laser sensors to perform its function. This is conducted when physical contact between the laser and gas happen, which triggers the alarm to send a signal to the control room that a leak has occurred.
- This device has a very fast response times, they are very precise targeted detection immune to most contaminants, capable of ppm level detection and the laser diode is not affected by the sun.
- Having said that, these devices are extremely expensive and may have a limitation to path length.

| | Response Speed | False Alarm Immunity | Outdoor Suitability | Detection Range | Maintenance Requirements | Relative Cost | Total |
|---|---|---|---|---|---|---|---|
| Laser Open Path Detector | Good | Very High | Excellent | Tens to Hundreds of Meters | Low to Moderate | High | 17 |

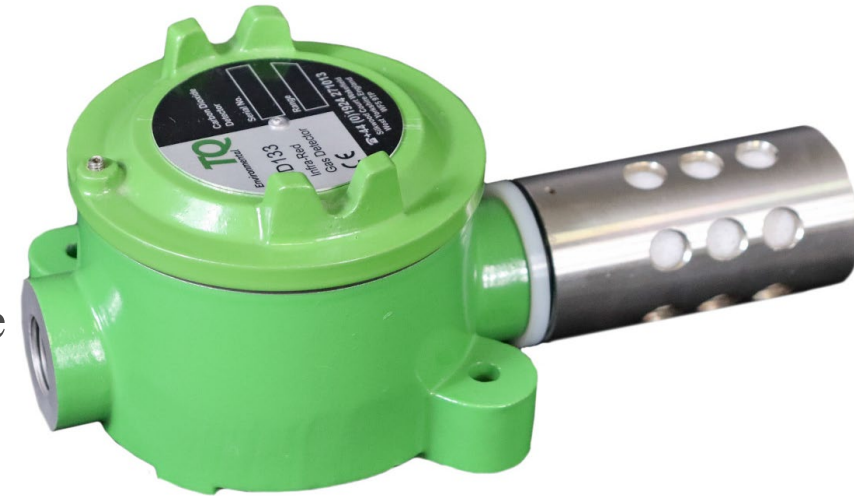
## Point IR Gas Detector

- Infrared gas detection is based on the unique IR absorption pattern associated with hydrocarbon gas and vapour. These devices emit infrared radiation through a gas sample, the amount of light absorbed at specific wavelengths indicates the concentration of gas present.
- These devices typically have two beams, an active beam that passes through any gasses and a reference beam that does not interact with the gas.
- Space or congestion prohibits the use of open path detectors so point IR gas detectors can be supplemented in. It will also need the detection of spot flammability at a particular location which is required.

| | Response Speed | False Alarm Immunity | Outdoor Suitability | Detection Range | Maintenance Requirements | Relative Cost | Total |
|---|---|---|---|---|---|---|---|
| Point IR Detector | Good | High | Excellent | Localised | Low | Moderate | 17 |

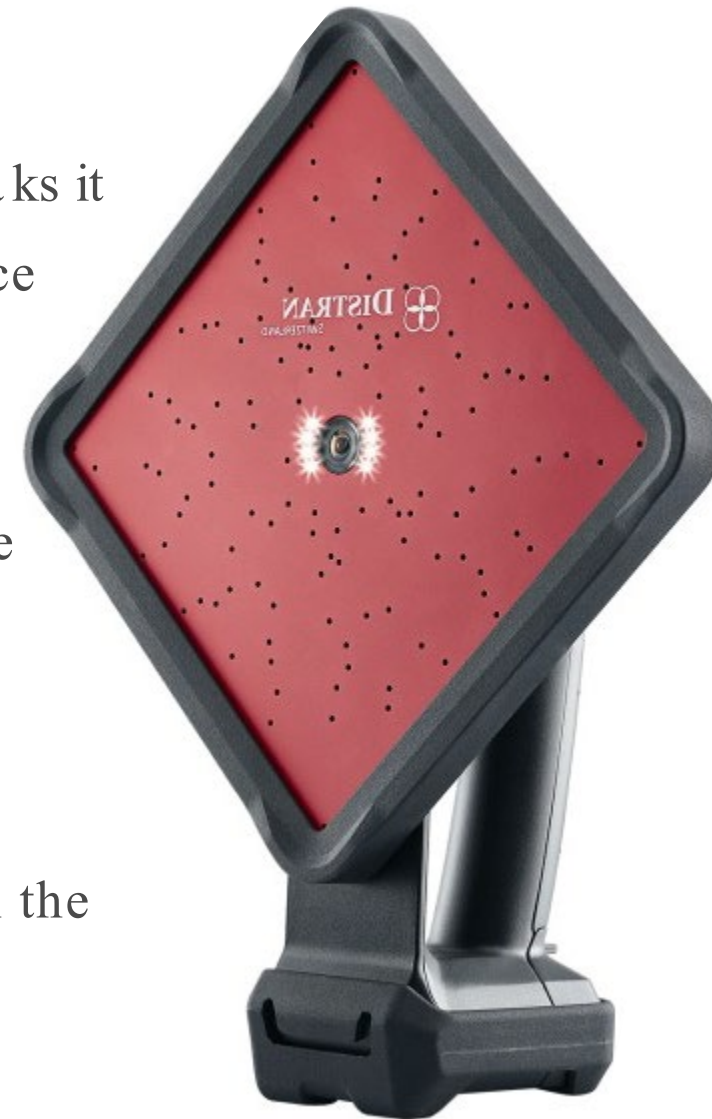
## Ultrasonic Gas Detector (Modern Alternatives)

- This device detects gas leaks through sounds. This is due to when gas leaks it will emit an ultrasonic energy. This will be detected by the acoustic device and will notify the control room that it has detected a gas leak.
- This device does not require a line of site and can still function even if the release is dispersed.
- In spite of that, the device is heavily influenced by background noise , it cannot differentiate between air and hazardous gas and will depend on the gas flow rates to detect that sound.

| | Response Speed | False Alarm Immunity | Outdoor Suitability | Detection Range | Maintenance Requirements | Relative Cost | Total |
|---|---|---|---|---|---|---|---|
| Ultrasonic Gas Detector (Acoustic) | Excellent | High | Excellent | Medium to Long Acoustic Coverage | Low | High | 17 |

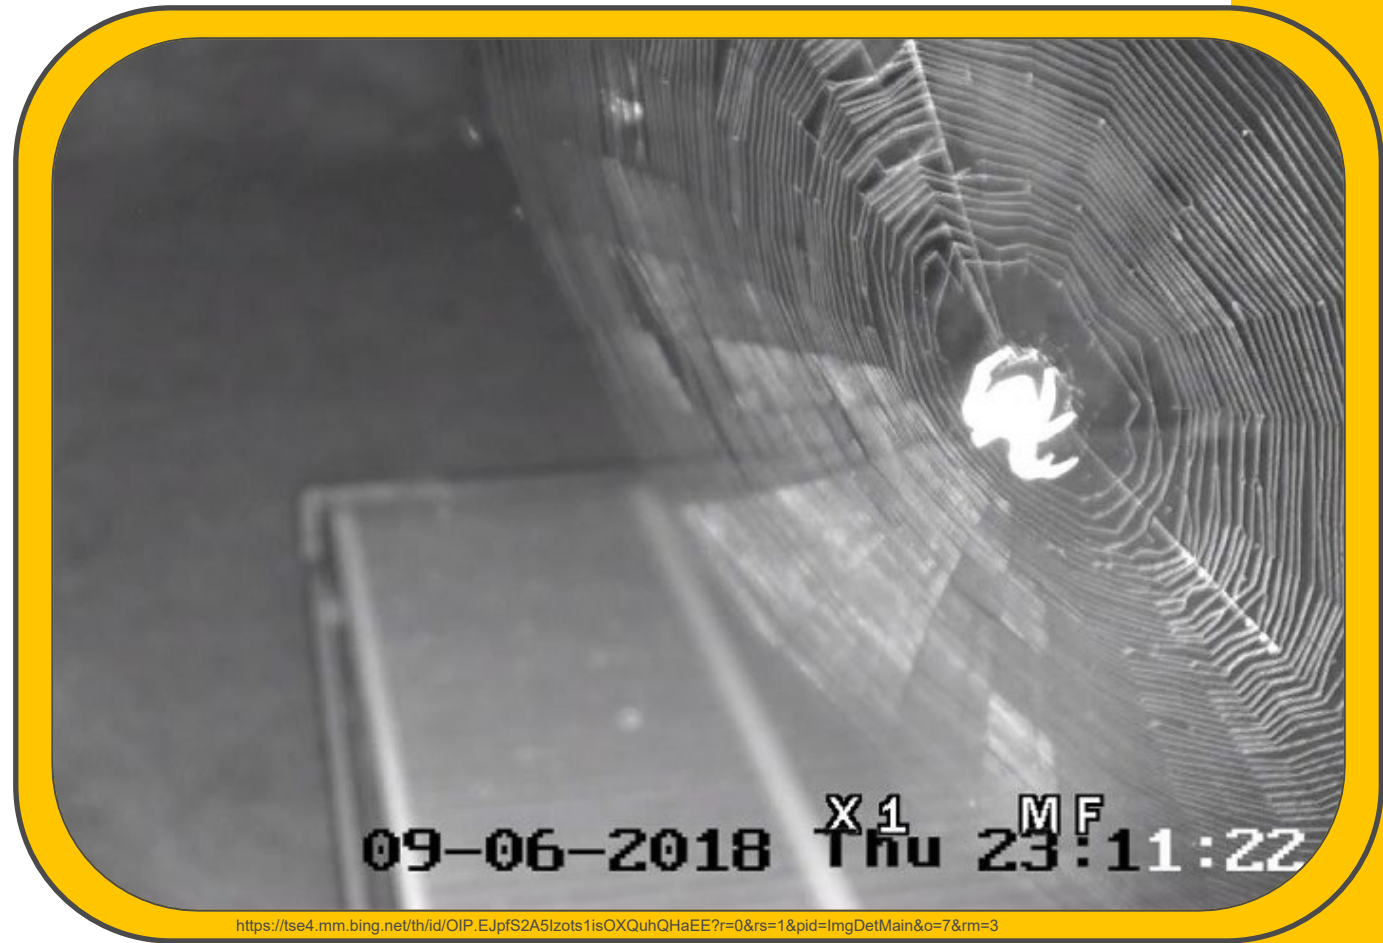
Moving onto, **animals**. Animals such as spiders and birds may nest in these cameras.

Spiders are attracted to the heat the sensor gives off and will nest inside them cause false alarms to occur due to the movement and heat from the spiders. This has happened multiple times at Bacton.
